Technical Service Bulletin

Subject: Roadranger - Eaton Fuller Oil Cooler Failure

TMIB-0124

Topic: Oil Cooler Failure Causing Lube Contamination

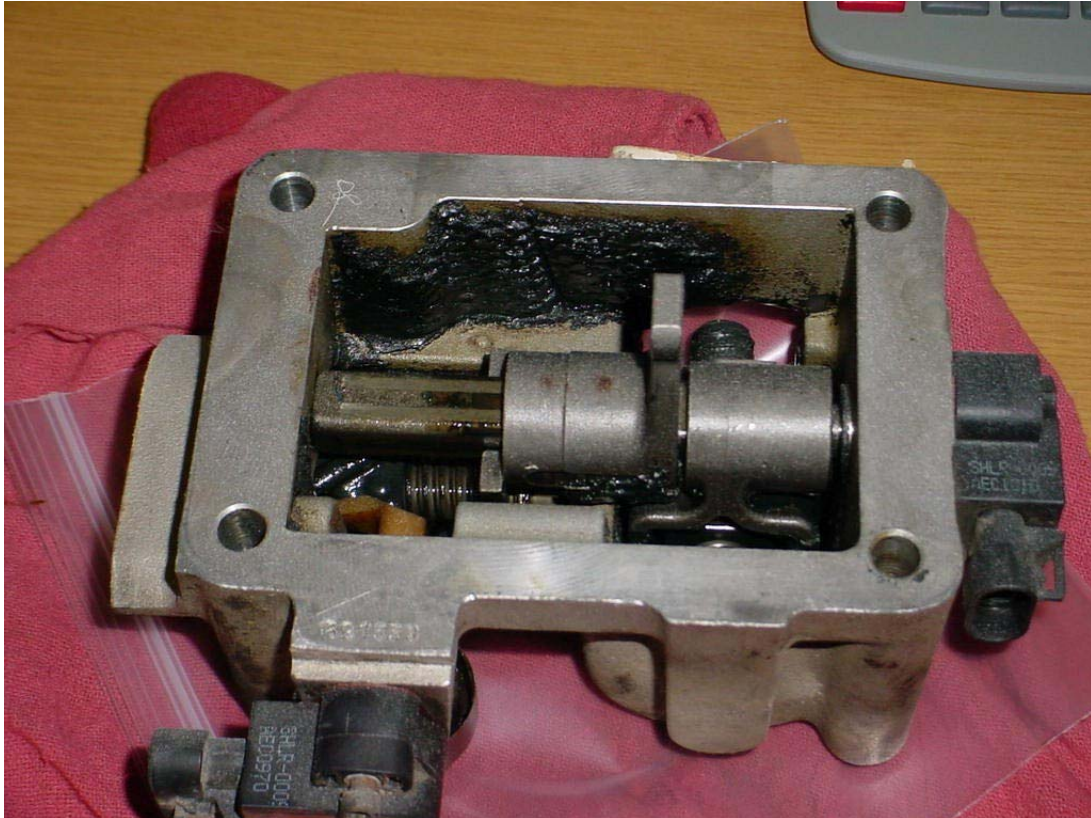
X-Y Shifter with sludge build up
(Recommend X-Y replacement)

11. Autoshift Transmissions that have an Eaton Oil Cooler that has failed shall have the X-YShifter replaced with new after completion of flush procedure

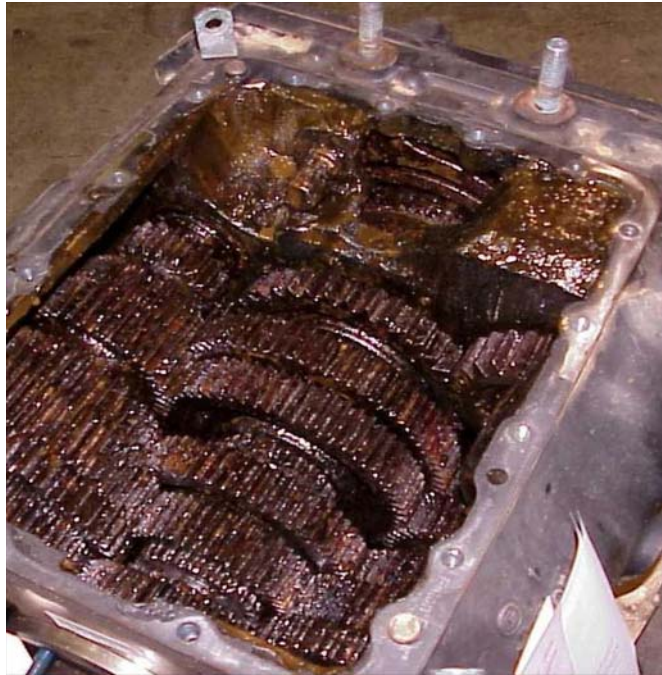
Transmission with tar build up
(Recommendation Transmission replacement)

Note: This flush procedure shall be performed on Transmissions that exhibit sludge like contamination i.e. (Milky residue). Transmission replacement is recommended on Transmissions that exhibit tar build up i.e. (Black thick sticky grease like residue). [If engine flush is required refer to the appropriate engine OEM for flushing procedures.](#)

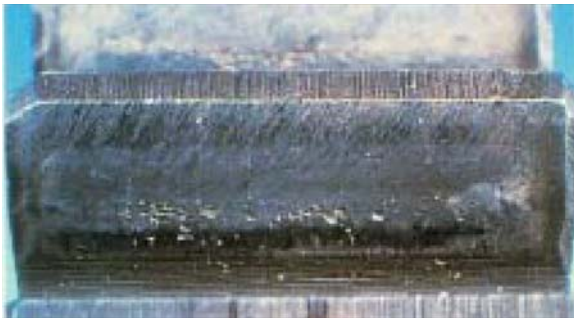
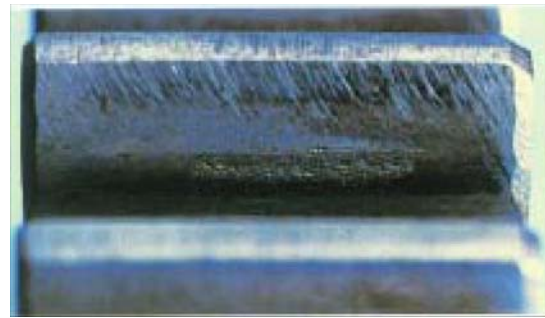
Initial pitting

Initial pitting may be considered normal gear wear. For assistance in identifying acceptable gear pitting please contact the RoadRanger Call Center at 1-800-826-4357

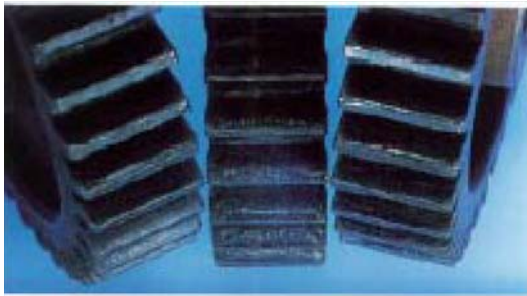
Heat Damage (burnt)
Replace Gear set

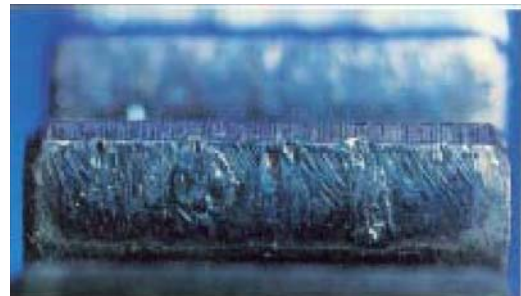
Scoring
Replace Gear Set
